New Mexico Historic Preservation Division  
Contract Number 35-12-41985.22

# Historic Taos County Courthouse Condition Assessment & Preservation Plan

September 27<sup>th</sup>, 2013

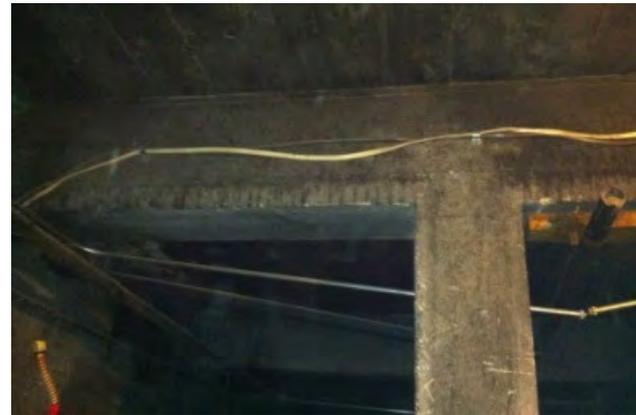
The entire basement area and all of the visible stem walls, are coated with a deep layer of black soot remaining from when the building had a functioning coal fired boiler. The coal shoot and abandoned mechanical piping, located on the north wall of the basement, are vulnerable to weather infiltration (freezing air and water/snow) and should be sealed up and concealed.

Figure 38. Concrete Column/Beam in Basement

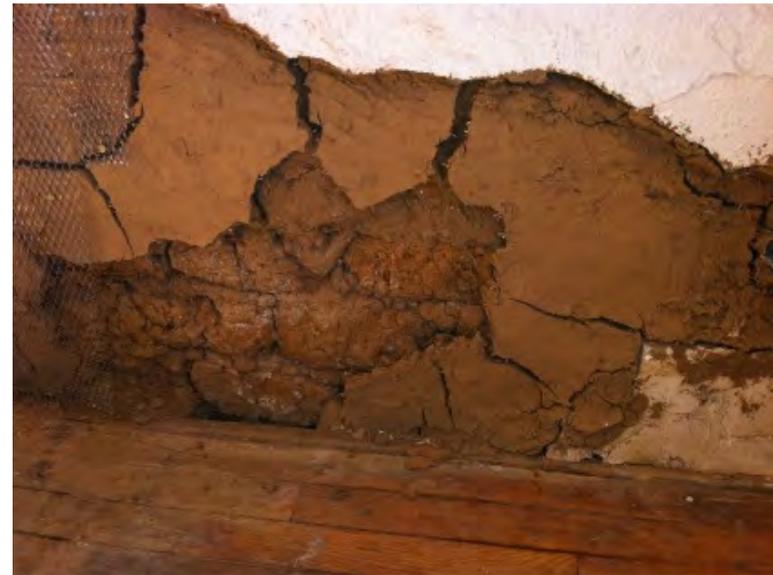
Figure 40. Interior plaster damage at the base of the second floor office located at the south east corner of the building

Overall the structure is in fair condition, with some damage to the exterior integrally-colored cement stucco causing spalling of the interior plaster, especially at the junction of the existing walls and the alley infill structures. The finish and color are consistent with neighboring structures. There is some damage to the stucco where, for instance, signs have been removed.

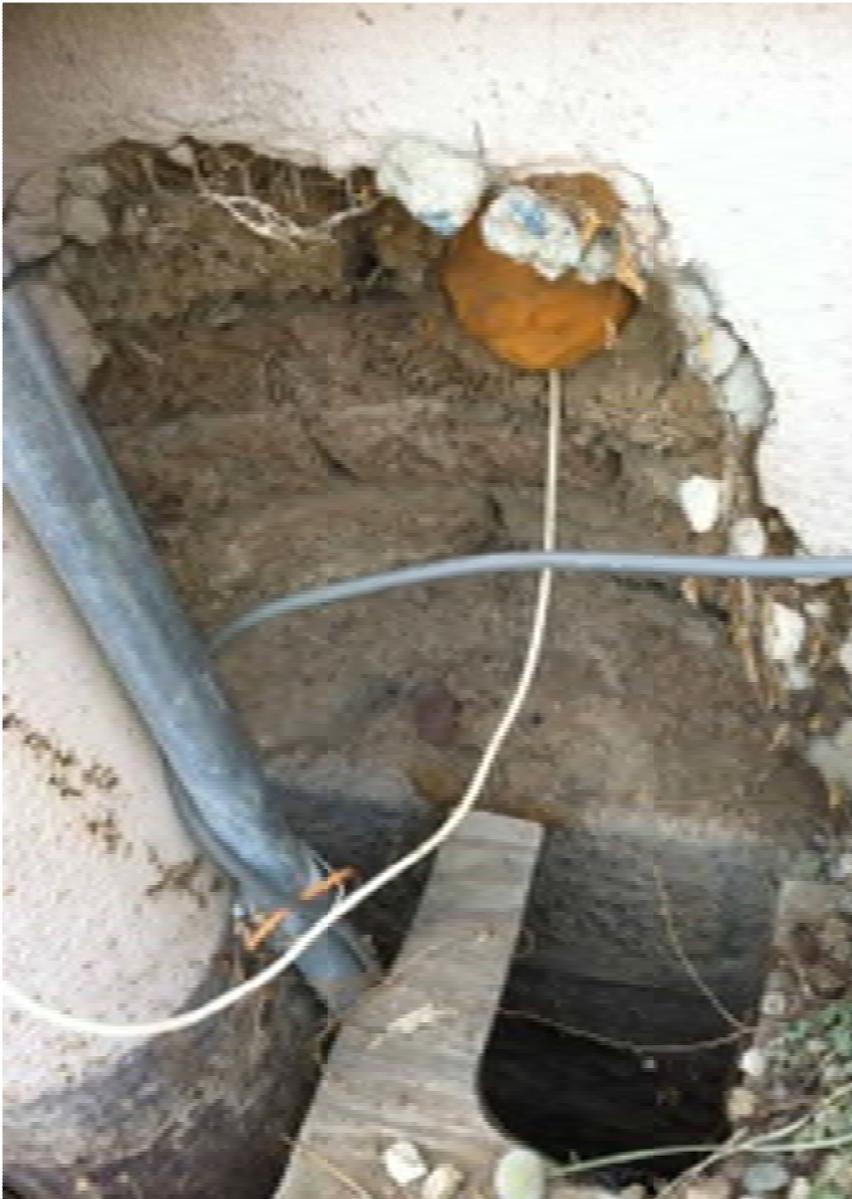
Figure 41. Exposed adobe & open coal chute @ base of north facade

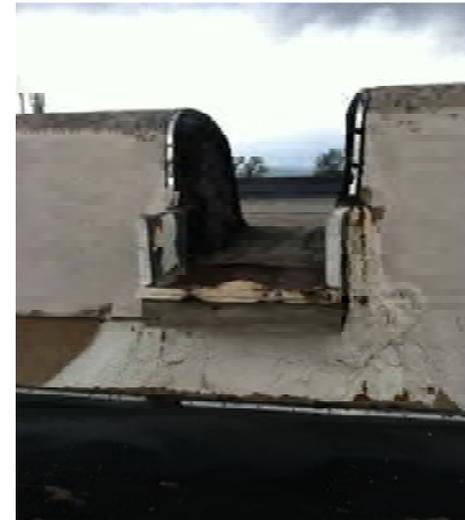
Figure 42. Metal lined wood canale at upper roof showing EPDM roof detailing and water damaged stucco

1. Canales should be replaced with wooden, clad, or metal canales appropriate to the period of significance.
2. Damage from poorly installed roofing and improperly detailed connections between neighboring structures should be addressed.
3. Wood at alley infill portals should be stained to match the remaining portal.
4. Painted wood that was originally painted should remain painted. Remove all loose paint and repaint as necessary.
5. Damaged or deteriorated wood members should be repaired with epoxy and replaced only when necessary.

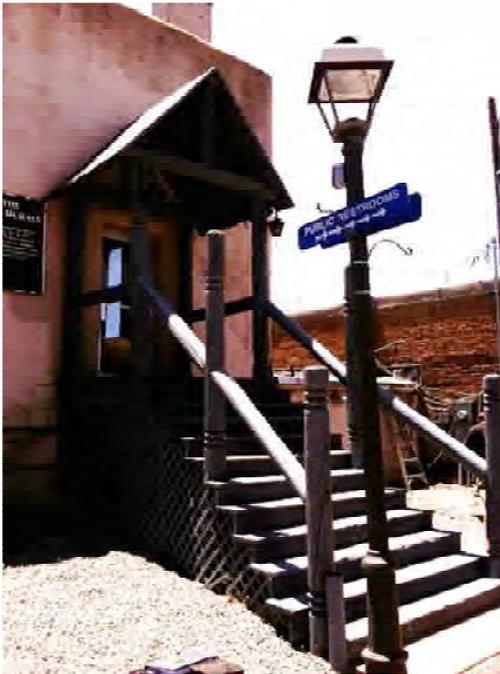
The covered, turned wooden stairway on the back, north facade of the building, was installed in the 1990's by local woodworker Eric Lambert. It runs perpendicular to the structure, as opposed to the original stair which ran parallel, according to the 1932 construction documents. The current stair, which is not consistent in appearance with the historic character of the building, is in good condition and does not presently need to be replaced.

Figure 43. Exterior covered stair at north façade

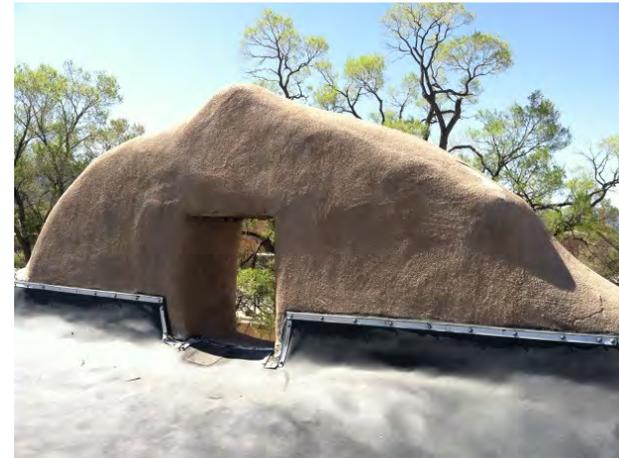
Efforts to insulate the roof in the later 1980’s or early 1990’s with spray applied poly-iso-cyanurate insulation have resulted in a roof surface that is uneven and poorly drained. The Town of Taos maintenance staff report that immediate removal of even small amounts of snow accumulation from the roof is essential in winter to prevent water damage to interior finishes. The EPDM membrane has been adhered directly to the uneven spray-foam insulation. This installation method is unconventional and not warrantable with roofing manufacturers today. Many areas of the roof have trapped air bubbles and delaminated membrane that allow for as much as 6” of vertical movement when walked upon. While not structurally dangerous, the current condition of the roof certainly warrants immediate replacement.

Figure 46. Roof side detail view of the upper parapet located at the front of the building

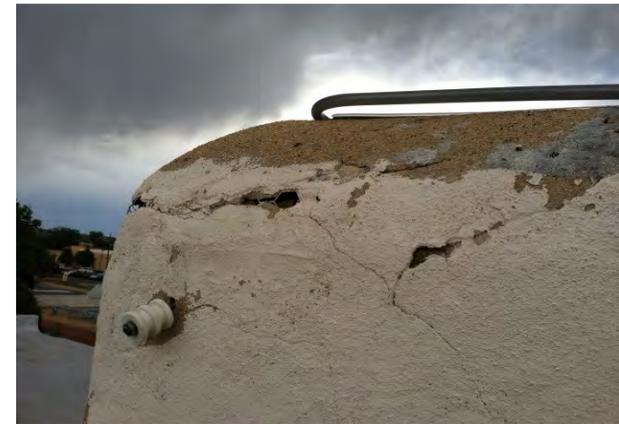
Figure 47. Parapet detail located at the southwest corner of the upper roof, note the abandoned electrical insulator, sever cracking, and temporary water proof coating on the stucco

All metal coping, flashing, canales, downspouts and gutters need to be removed, refabricated and replaced. The north roof edge of both infill additions is a simple 2” galvanize metal drip edge that is in poor condition with exposed or missing fasteners that have rusted, separated seams, and ponding in the associated gutters.

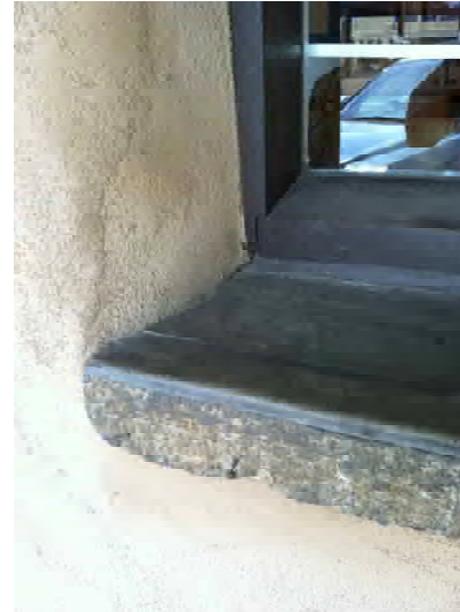
Figure 48. Concrete and rough sawn lumber window sill detail located at first floor Entry Portal

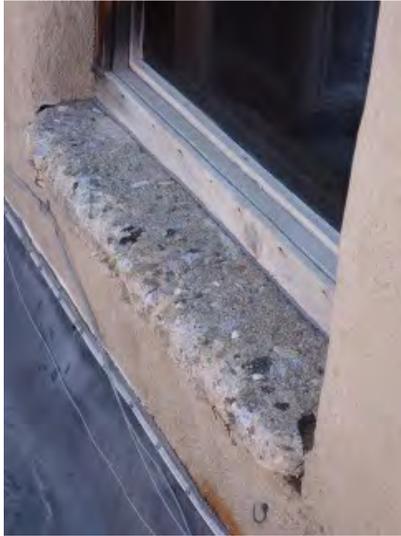
Figure 49. Damaged concrete sill located at the second floor West Façade

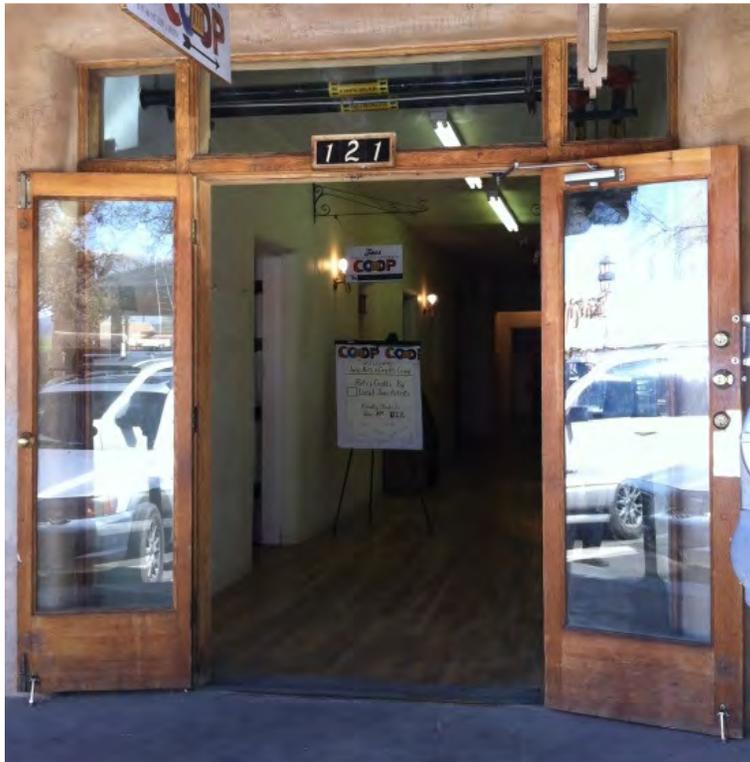
Figure 51. Non-historic front entry door

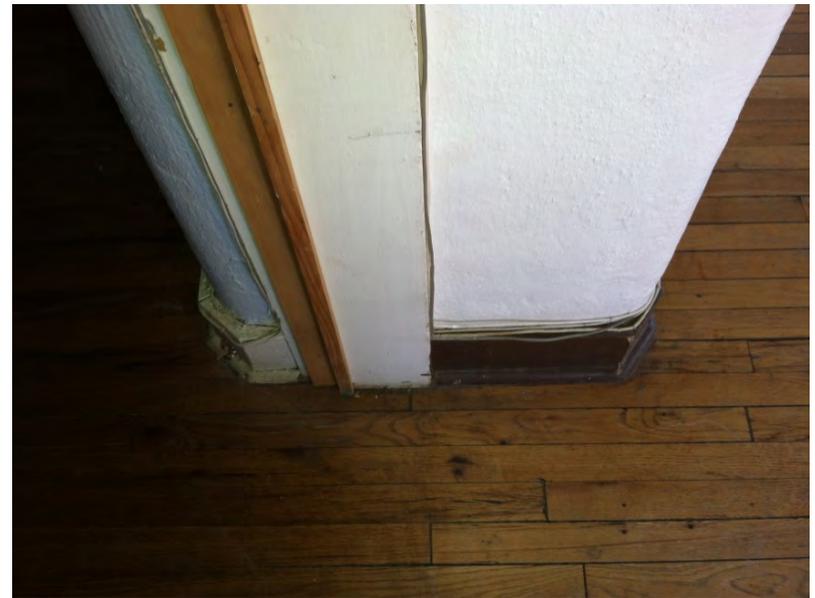
Figure 56. Exposed low voltage wiring located on the historic wood baseboard trim in first floor Corridor – typical condition at numerous locations

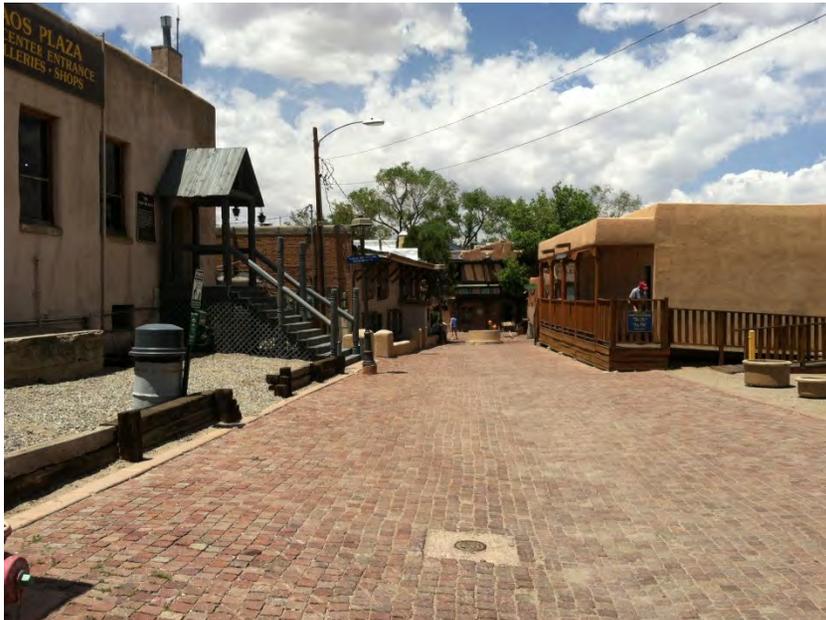
Figure 62. View of Juan Largo Lane, looking west, note that the elevation of the roadway is approximately thirty six inches higher than the first floor elevation of the Historic Old Taos County Courthouse

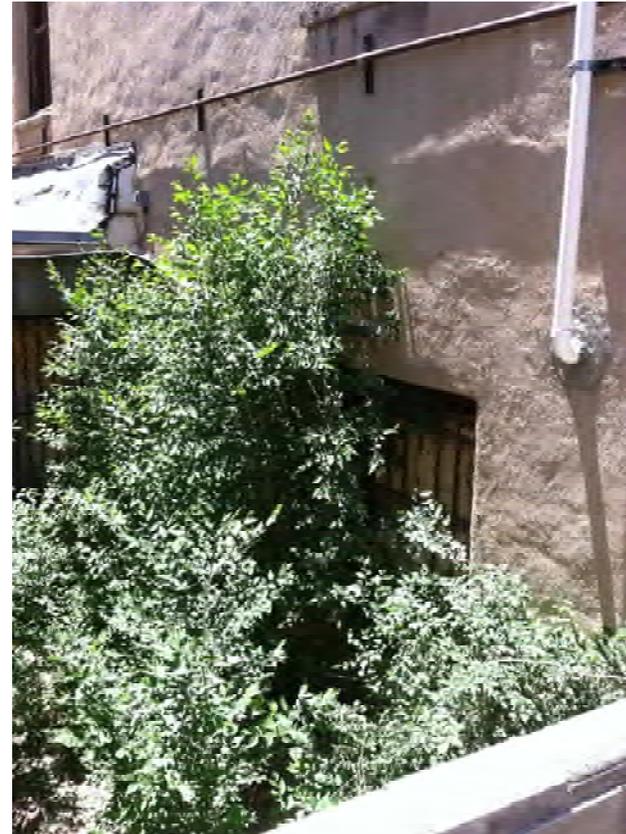
Figure 63. Sunken outdoor court area located at northern end of the east alley infill, note weeds, invasive Siberian Elm trees, and severely deteriorated condition of exterior stucco and windows
