New Mexico Historic Preservation Division  
Contract Number 35-12-41985.22

# Historic Taos County Courthouse Condition Assessment & Preservation Plan

September 27<sup>th</sup>, 2013

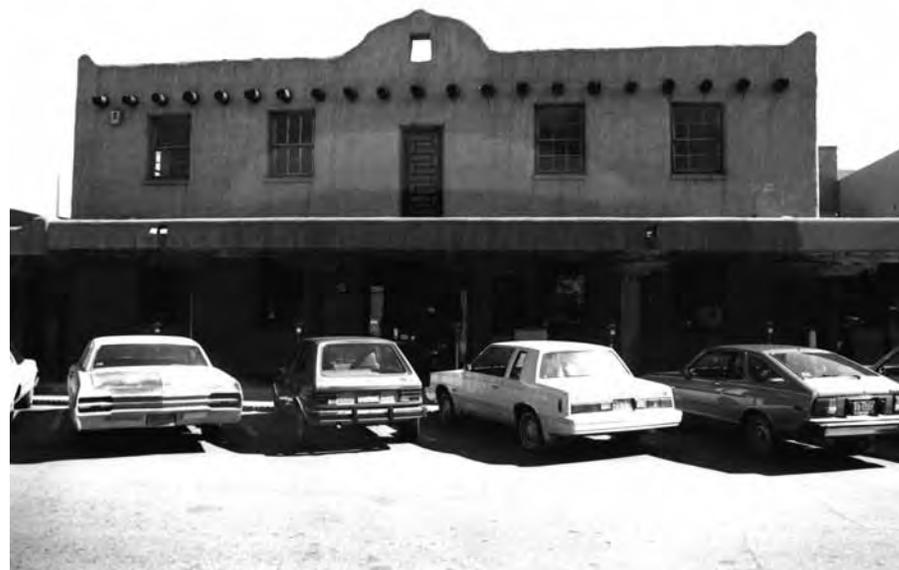
Figure 24. South Facade from 1982 National Register nomination. Note the missing viga tails, the stucco fascia, and the change in massing of the portal

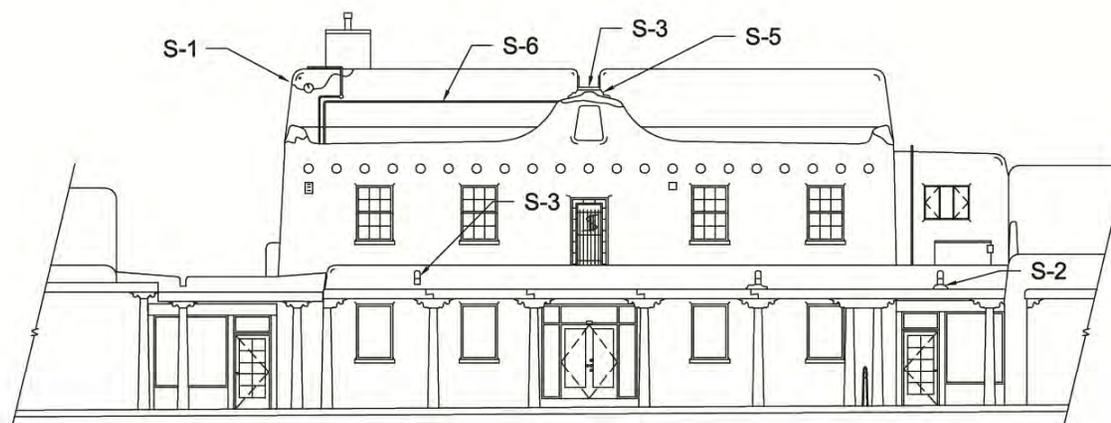
Figure 34. Existing Conditions Evaluation - South Elevation

| <p>S-1 Damaged cementitious stucco. Cracked, spalling finish coat and undercoat. Exhibits signs of water damage and water infiltration. Surface of stucco has accumulated deep layers of dirt, grime, bird droppings, and moss/algae growth in shaded areas. Multiple locations.</p> <p>S-2 Severely cracked, spalling cementitious stucco system directly below drainage canale. Water damage is evident. Stucco mesh/building paper is visible</p> <p>S-3 Galvanized metal drainage canale. Metal is damaged, warped, bent, cracked.</p> <p>S-4 Exposed 10" wood viga end. Shows signs of water infiltration. Wood is cracked, and exhibits signs of "dry-rot".</p> <p>S-5 Exposed (painted) polyiso rigid spray insulation showing signs of decay from exposure to UV sunlight. Insulation is damaged, soft to touch, and unstable. Perimeter has shrunk away from surrounding cementitious stucco allowing water to migrate into adobe wall.</p> | <p>S-6 Exposed galvanized metal electrical conduit - surface mounted. Joints are loose, conduit has separated from wall in multiple locations. Multiple locations on all facades. Some circuits appear to be non-functional and/or abandoned.</p> |

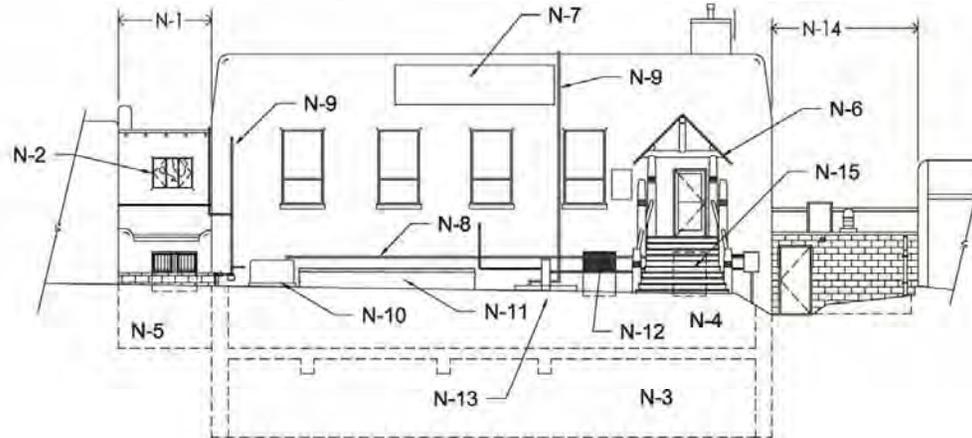
Figure 35. Existing Conditions Evaluation – North Elevation

- N-1 East Alley addition. Likely constructed in 19XX.
- N-2 Steel sash casement windows ca. 1960's. Single pane glass, painted metal frame, glass is broken or missing in multiple locations.

- N-3 Basement with unfinished earth floors, cast-in-place board formed concrete walls/ceiling/beams. Original boiler abandoned ca. 2010 and replaced with new hydronic boiler in first floor mechanical room.

- N-10 High voltage electrical transformer at grade.
- N-11 Cast-in-place concrete enclosure for original jail cell below. Concrete is spalling due to continuous exposure to freeze/thaw cycles for the past 80 years. Large aggregate is exposed and fragile.

- N-12 Original 3/8" diameter steel security grille. Original window has been replaced with modern decorative stained glass and the remaining window opening has been infilled with masonry below.

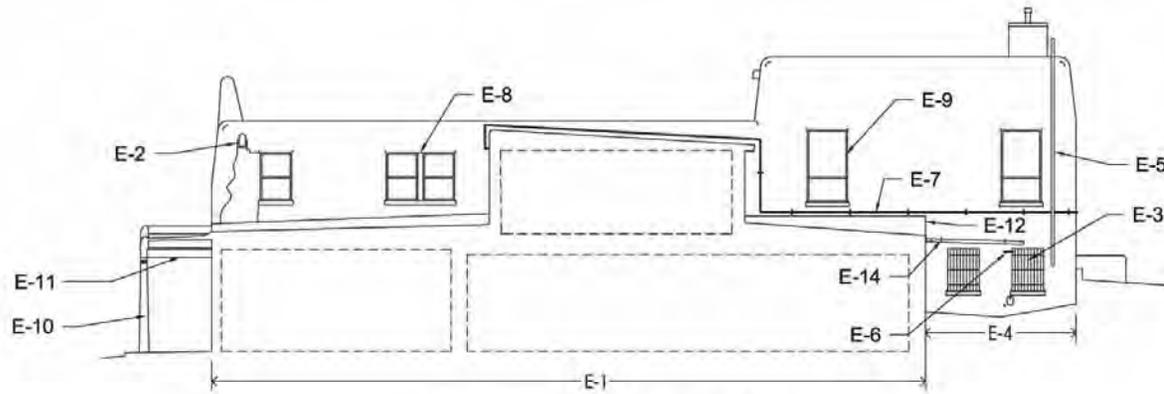
Figure 36. Existing Conditions Evaluation – East Elevation

| <p>E-1 East Alley addition ca. 1940's?</p> <p>E-2 2x wood canale lined with galvanized metal. Area directly below canale is water damaged and shows signs of water infiltration into adobe wall assembly. Stucco has bulged out and shows signs of previous repair work.</p> <p>E-3 Original wood "jail cell" windows are damaged beyond repair and missing many components. Rough opening is boarded up with plywood. Original security bars consisting of 1/2 diameter steel bars welded to 1/4"x2" flat bars are intact. Stucco at opening is severely damaged and adobe bricks are exposed to weather at both windows.</p> <p>E-4 Sunken exterior utility courtyard, open to sky, and contained by a low cmu wall separating the courtyard from the north alley. Finish grade of the courtyard sits approximately 12" above finish floor of the First Floor, and appears to not drain to any point outside of the courtyard...potentially allowing storm-water to accumulate. Area is overgrown with weeds, debris, and numerous Siberian Elm tree sapplings. Area is unsafe, unlit, and collects trash.</p> <p>E-5 Exposed galvanized metal mechanical flue from abandoned water or space heater.</p> | <p>E-6 Exposed 1" flexible electrical conduit mounted to face of building.</p> <p>E-7 Exposed 1-1/2" natural gas line surface mounted to face of stucco.</p> <p>E-8 Original wood sash single pane windows with original hardware intact. All units suffer from lack of maintenance and have been screwed shut for security reasons. Sill and jamb trim are weathered &amp; cracked.</p> <p>E-9 Courthouse/Mural Room windows appear to be the original frames with the exterior wood stops replaced with in kind material. Glazing is single pain. All units in this room are in fair condition. Clear finish on exterior exhibits decay from UV and weather exposure.</p> <p>E-10 10" diameter wood columns throughout the south portal. Columns sit directly on concrete paving below and exhibit some cracking and warping due to weather exposure and moisture migrating up from the concrete paving. Dark Brown paint.</p> <p>E-11 8" diameter vigas at 30" o.c.. Brown paint. Majority of vigas are in fair condition. Several vigas shows signs of being spliced or repaired at mid-span in the past, no signs of sagging or failure.</p> <p>E-12 Exposed EPDM roofing membrane with galvanized metal termination strip.</p> <p>E-14 Galvanized metal gutter surface mounted to face of stucco and dischargin directly to grade below.</p> |

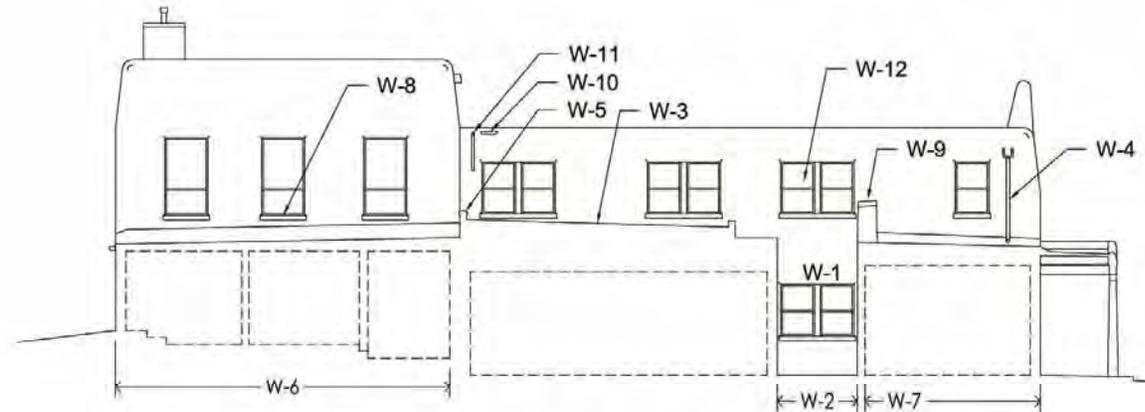
Figure 37. Existing Conditions Evaluation – West Elevation

| <p>W-1 Wood sash window, boarded up and plastered over on inside of wall.</p> <p>W-2 Exterior light well. Originally part of West Alley.</p> <p>W-3 60mil EPDM roofing membrane with exposed galvanized closure strips. Membrane is approximately 20 years old, shows signs of significant wear, and is close to the end of its useful life.</p> <p>W-4 4" pvc downspout connected to 2x8 wood canale lined w/ galvanized metal &amp; flashed with EPDM roof membrane. Downspout discharges directly on to EPDM roof membrane below.</p> <p>W-5 Ceramic wall coping/tile with brown glaze, layed directly over EPDM roof membrane. Tiles are loose, some are cracked.</p> <p>W-6 West Alley infilled with new jail cells ca. 19XX?</p> <p>W-7 Retail Shop ("Smoke Signals") added to West Alley ca, 194x?</p> <p>W-8 Cast in place concrete window sill. Extremely deteriorated. Typical of multiple sills. Existing concrete is cracked, spalling, &amp; has exposed rough aggregate. Exhibits signs of many years of freeze-thaw damage.</p> | <p>W-9 Cementitous chimney flue for kiva fireplace below. Non-functioning/abandoned.</p> <p>W-10 Rough sawn wood blocking embed in adobe wall/stucco. Remnant of strucural support for roof access ladder previously removed? Wood member has shrunk/twisted and is seperated from the stucco allowing moisture into wall cavity.</p> <p>W-11 Overhead phone service entrance from pole in north alley.</p> <p>W-12 Original wood sash single pane windows with original hardware intact. All units suffer from lack of maintenance and have been screwed shut for security reasons. Sill and jamb trim are weathered &amp; cracked.</p> |

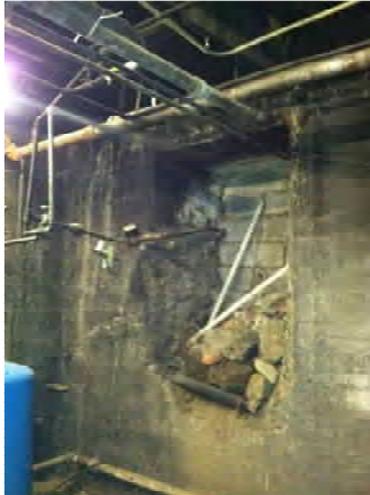
The entire basement area and all of the visible stem walls, are coated with a deep layer of black soot remaining from when the building had a functioning coal fired boiler. The coal shoot and abandoned mechanical piping, located on the north wall of the basement, are vulnerable to weather infiltration (freezing air and water/snow) and should be sealed up and concealed.

Figure 39. Abandoned coal chute and mechanical piping on north wall of basement

1. Clean the exposed concrete foundation & stem-walls of all built up grime and coal soot residue in the interior of the basement.
2. Remove all loose debris, unstable patches, infill material, and abandoned ducts or piping from the coal chute, and abandoned flue and replace with solid cast-in-place concrete.
3. Remove the built up earth that has accumulated in the north alley against the building. Re-grade the north alley to provide positive drainage away from the

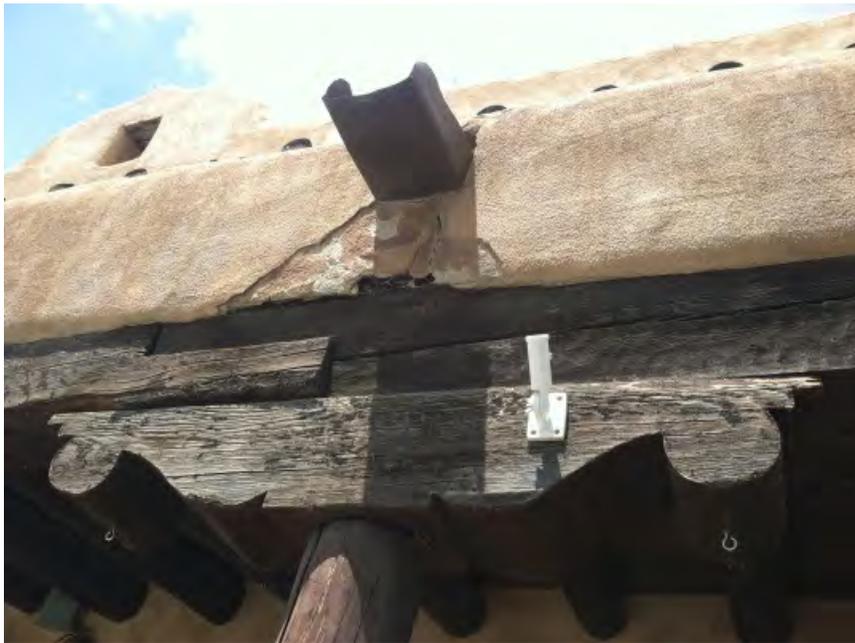
The roof is drained from poorly fitted metal "canales" formed of recycled gutters and downspouts in a flat parapet. The south portal is distinguished by a cast-in-place concrete obelisk-shaped hitching post on the east, very likely used to tie up horses or animals for the members of the community who still use them. An exposed viga east of the front entry doors shows signs of being spliced some time ago, but is structurally sound and the repair was performed very well. Portions of the portal in front of the alley infills have been replaced in the past year. These remain unpainted or stained.

Figure 44. Typical Canale and Wood Corbel of the Entry Portal

1. Canales should be replaced with wooden, clad, or metal canales appropriate to the period of significance.
2. Damage from poorly installed roofing and improperly detailed connections between neighboring structures should be addressed.
3. Wood at alley infill portals should be stained to match the remaining portal.
4. Painted wood that was originally painted should remain painted. Remove all loose paint and repaint as necessary.
5. Damaged or deteriorated wood members should be repaired with epoxy and replaced only when necessary.

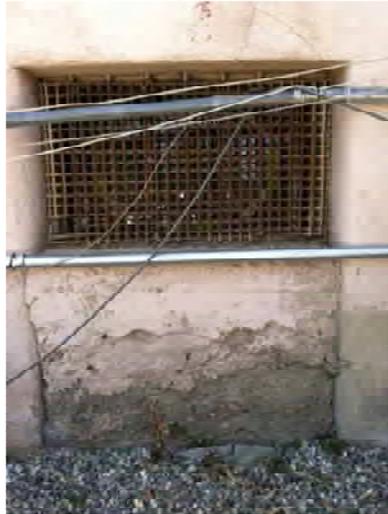
Figure 50. Infilled window opening located at the north Basement Façade

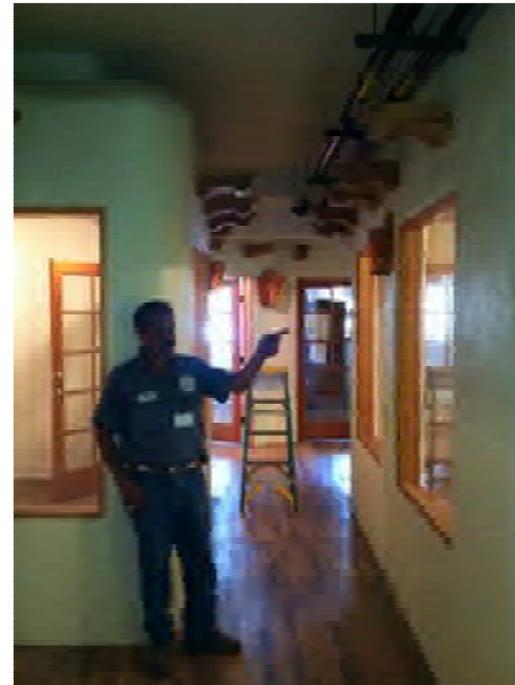
Moderate remodeling has been completed on the interior, in the form of modern interior walls and wooden “storefront” glazing on the first floor. These remodeled interior partitions consist of 2x4 wood stud framing with ½” gypsum wall board sheathing that has been taped and mudded with modern gypsum finishing techniques, mostly “orange peel texture”, and finally painted. The second floor retains its original floor plan configuration. Many of the later infill and remodeled spaces of the first floor were constructed using inexpensive modern materials and poor craftsmanship that are not appropriate for a substantial public building of this type. Refer to *Figure 22* included earlier in this report for locations of these modern infill partitions.

Figure 52. Non-historic interior partitions, carved wood canales, and interior windows

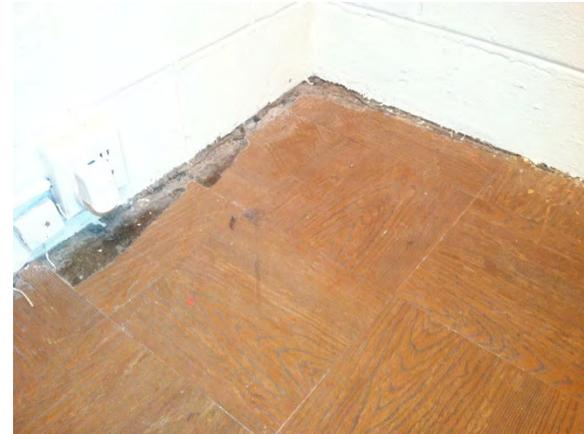
The jail cell is unique in that it has ¼" steel plate on all surfaces, including the ceiling and floor. The steel plate in the oldest cell has been stripped of its lead containing paint and currently is in need of a new painted finish. The jail addition, located in the west alley, is constructed out of 8" thick concrete masonry unit (cmu). The cmu is painted and visible on the north alley façade. All of the exposed cmu walls are painted white. Ceilings, in the jail addition, are painted sheet metal panels placed within a metal trim system that is spaced two feet on center and mounted directly to what appears to be a cast-in-place concrete ceiling deck. The jail cell additions in the west alley have vinyl floor tiles that are in very poor condition.

Figure 54. Vinyl floor tile located in the west alley jail cells

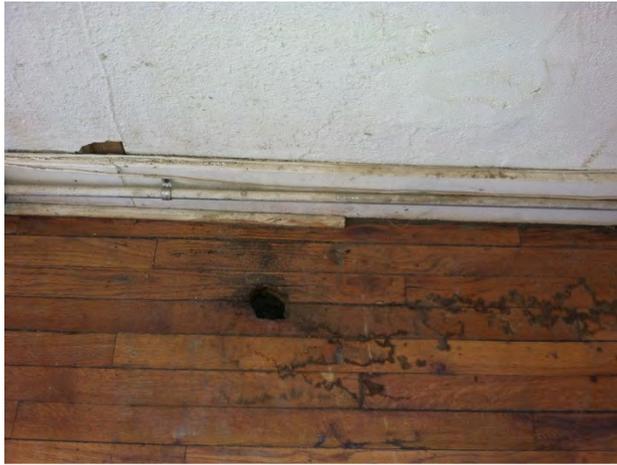
The majority of the flooring in the remainder of the building is either two inch wide tongue and groove wood with a clear sealer, or modern carpet. The wood floors are in fair to good condition with evidence of refinishing performed in the last ten years. While the flooring is in good/fair condition, it is at the end of its useful life. It is too thin to be refinished. Further sanding will damage the substrate. Carpet throughout the building is in poor condition, with multiple ripples, tears, and taped seams. There is no significant

Figure 55. Wood flooring with radiator removed

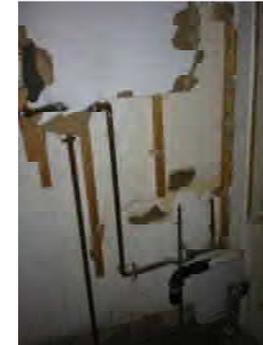
The building's plumbing system is deficient. Water closets, urinals, lavatories and sinks are either missing or in very poor condition. No restrooms exist in the building making it non-code compliant. The one exception is a single water closet and lavatory located on first floor in the historic jail. The fixtures in this small restroom are non-historic and in poor condition. The fixtures have not been maintained. They have grime and dirt build-up, mineral deposits, and un-insulated supply lines.

Figure 57. Abandoned restroom on second floor

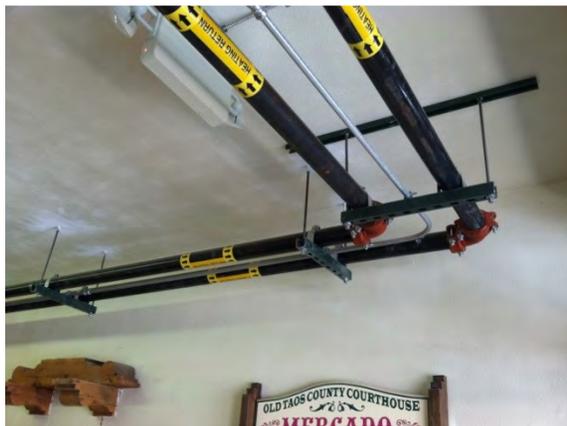
Figure 58. Exposed hydronic heating pipes on ceiling of first floor Corridor installed as part of mechanical upgrade in 2010

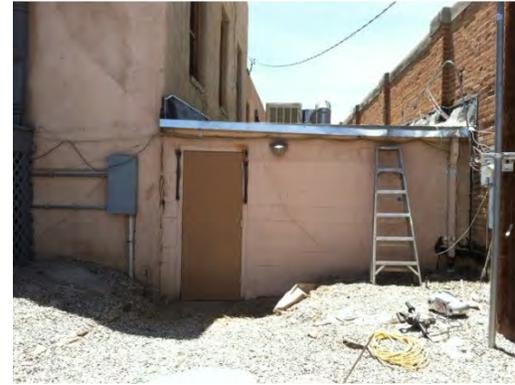
The floor between the basement rooms and the remainder of the structure is a concrete beam and slab, while the remainder of the first floor is framed with 2x8's, and the second floor with 3x12's. Structural wood framing throughout is in surprisingly good condition. The general condition of the structural concrete foundations and stem walls is good. One area of concern is the threat of water infiltration due to the grade at the north alley being raised over the years. A water

Figure 61. Raised grade of north alley

proof membrane and appropriate drainage system should be installed or the adjacent grade should be modified to provide for positive drainage in this area of the building.
